TECHNICAL NOTE

No. 1427

LABORATORY INVESTIGATION OF ICE FORMATION AND  
ELIMINATION IN THE INDUCTION SYSTEM OF A  
LARGE TWIN-ENGINE CARGO AIRCRAFT

By Willard D. Coles

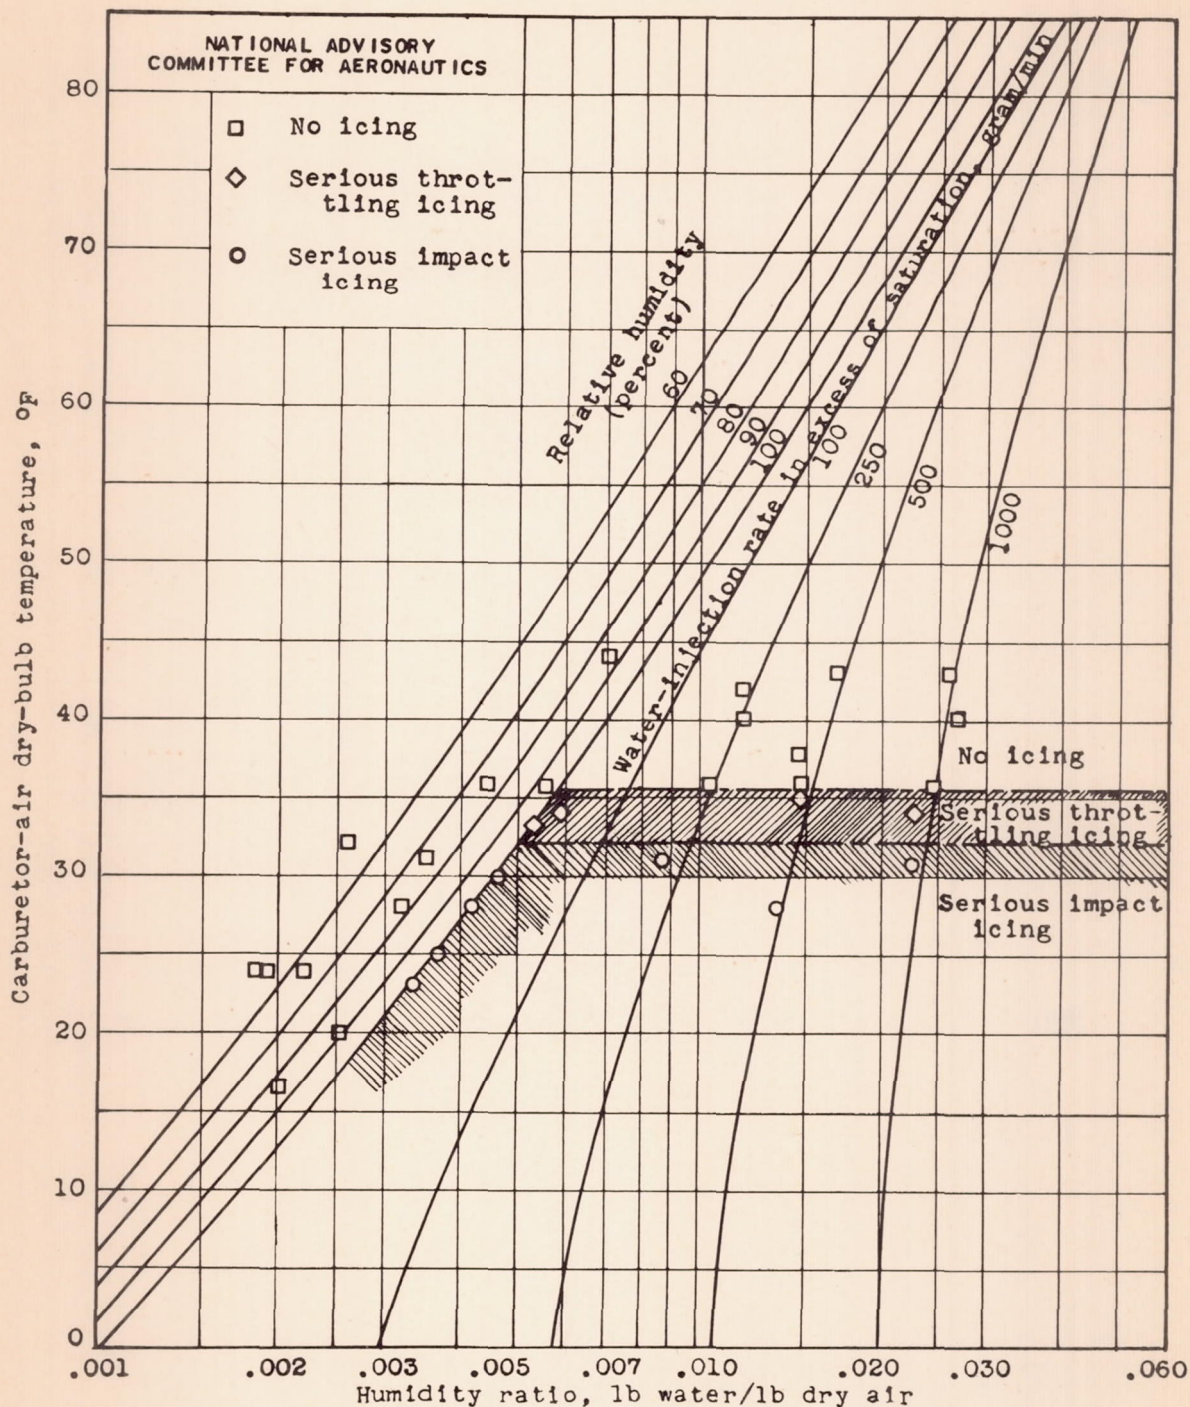
The limits of no icing, serious throttling icing, and serious impact icing are plotted against carburetor-air dry-bulb temperature and humidity ratio in figure 4. These data show that for the operating conditions used in these experiments this induction system is ice-free at any humidity ratio less than saturation or at carburetor-air temperatures above 36° F with any humidity ratio. At carburetor-air temperatures between 32° and 36° F, no appreciable difference in appearance or effect of the ice formation occurs as a result of fuel injection, which indicates that ice in this range is caused solely by the expansion cooling of air by carburetor throttling. At carburetor-air temperatures below 32° F, throttling continues to have an effect upon the ultimate ice accretion in the system but is less significant than impact icing.

Figure 4. - Icing characteristics of engine induction system.

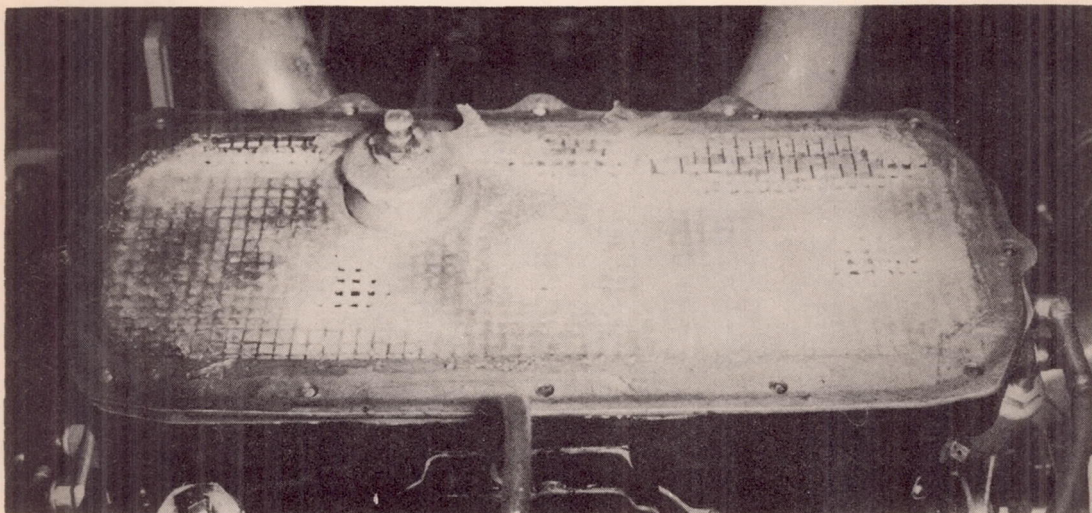
flat and fits very closely to the boost venturi, became iced (fig. 5(a)) to the extent that air flow was reduced 50 percent in 6 minutes at a carburetor-air temperature of  $28^{\circ}$  F with a water-injection rate of 500 grams per minute (humidity ratio, 0.0136). When such icing occurs, the metering of the carburetor can be impaired without any ice forming on the air-metering parts because of reduced air flow through the boost venturi. Water passing through the screen before it is blocked with ice causes ice formation on the venturi, boost venturi, and impact tubes (fig. 5(b)) and results in excessively rich or lean mixtures dependent upon the principal location of the ice.

(a) Screen icing.

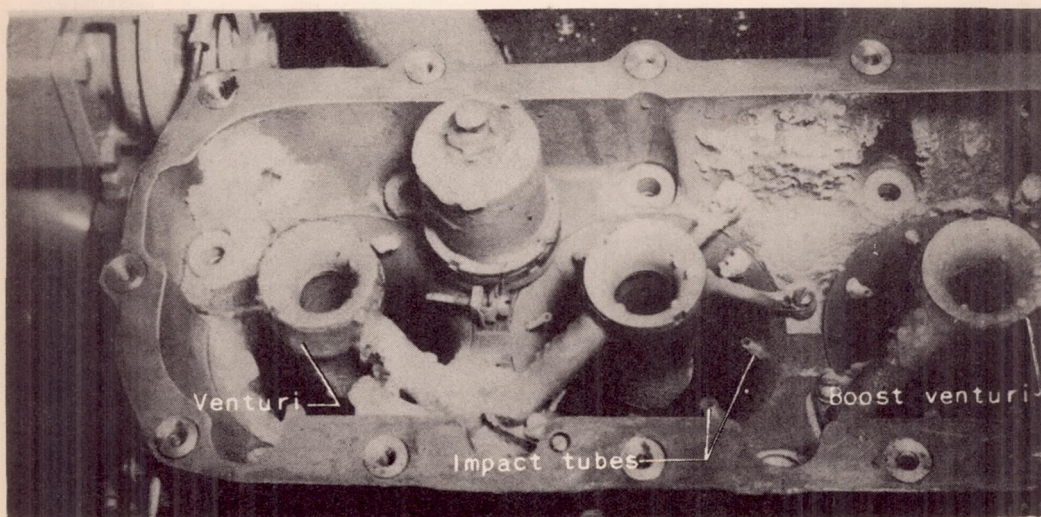
(b) Venturi, boost-venturi, and impact-tube icing.

Figure 5. - Impact-ice formations on carburetor screen and carburetor top deck.

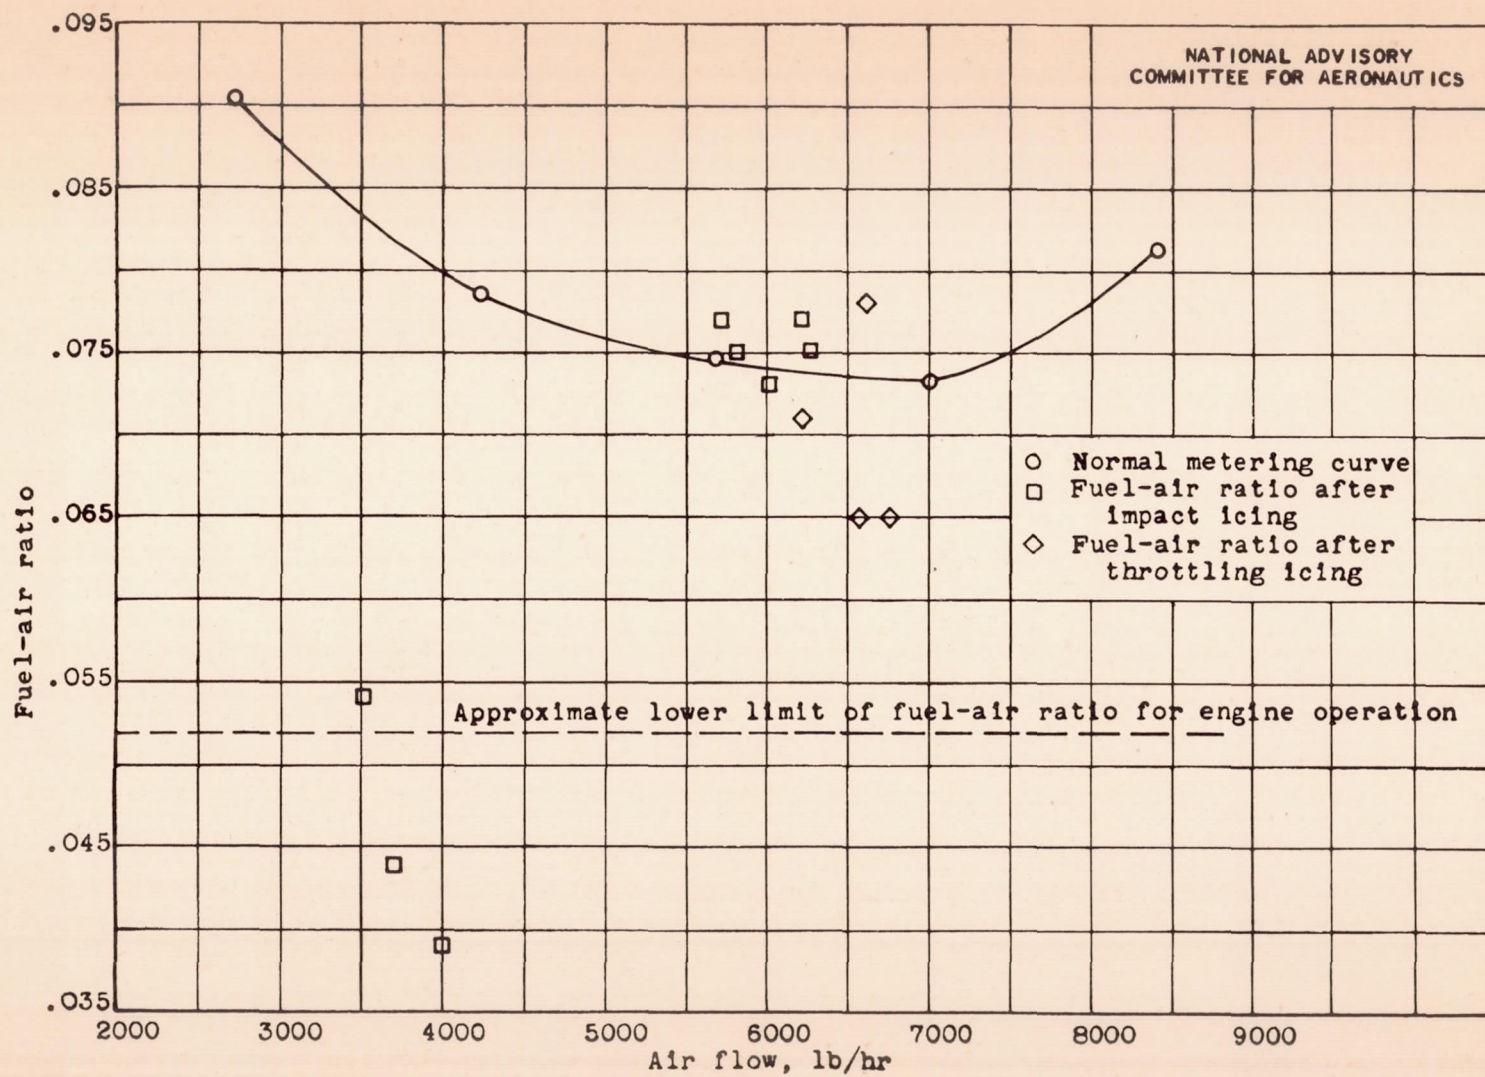
Figure 6. - Fuel-air ratios obtained after 15 minutes of serious icing compared with flow-bench-calibration results showing normal metering.

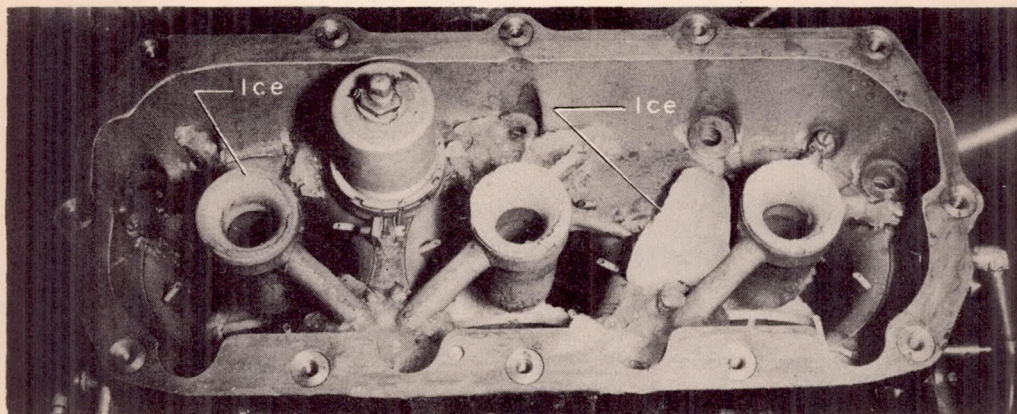
Under very light impact-icing conditions at a temperature of 29° F when the carburetor-entrance screen was not used, little ice formed on the carburetor (fig. 7(a)), a heavy deposit formed on the throttle plates (fig. 7(b)), and a trace of ice was observed on the top inlet-guide vane at the supercharger-impeller entrance (fig. 7(c)). This ice did not seriously affect operation during a 3-hour run; the top guide vane makes poor thermal contact with the warm walls of the inlet elbow and is the location most susceptible to ice formation below the carburetor. (See fig. 7(c).)

(a) Carburetor top deck.

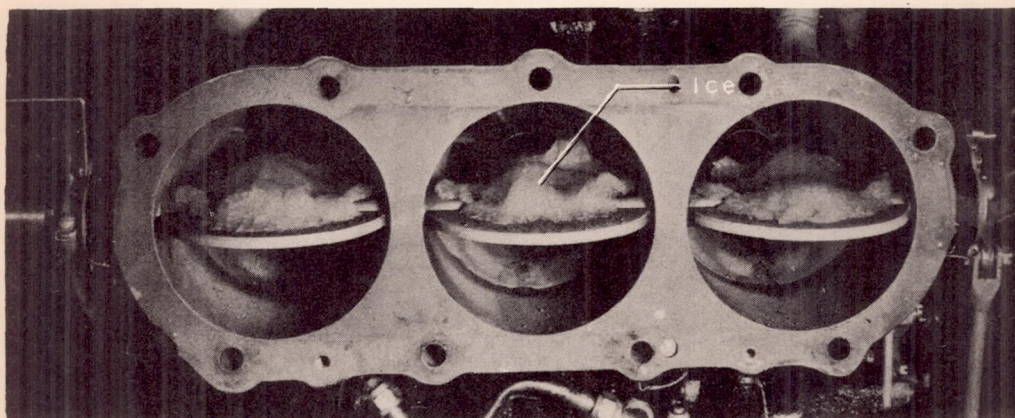
(b) Throttle plates.

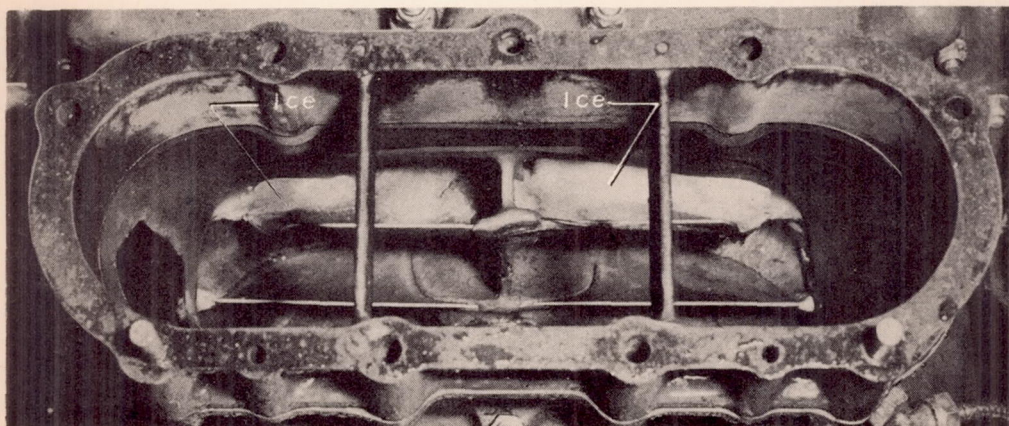
(c) Supercharger-impeller entrance vanes.

Figure 7. - Impact-ice formation on carburetor and supercharger turning vanes after 3 hours of icing.

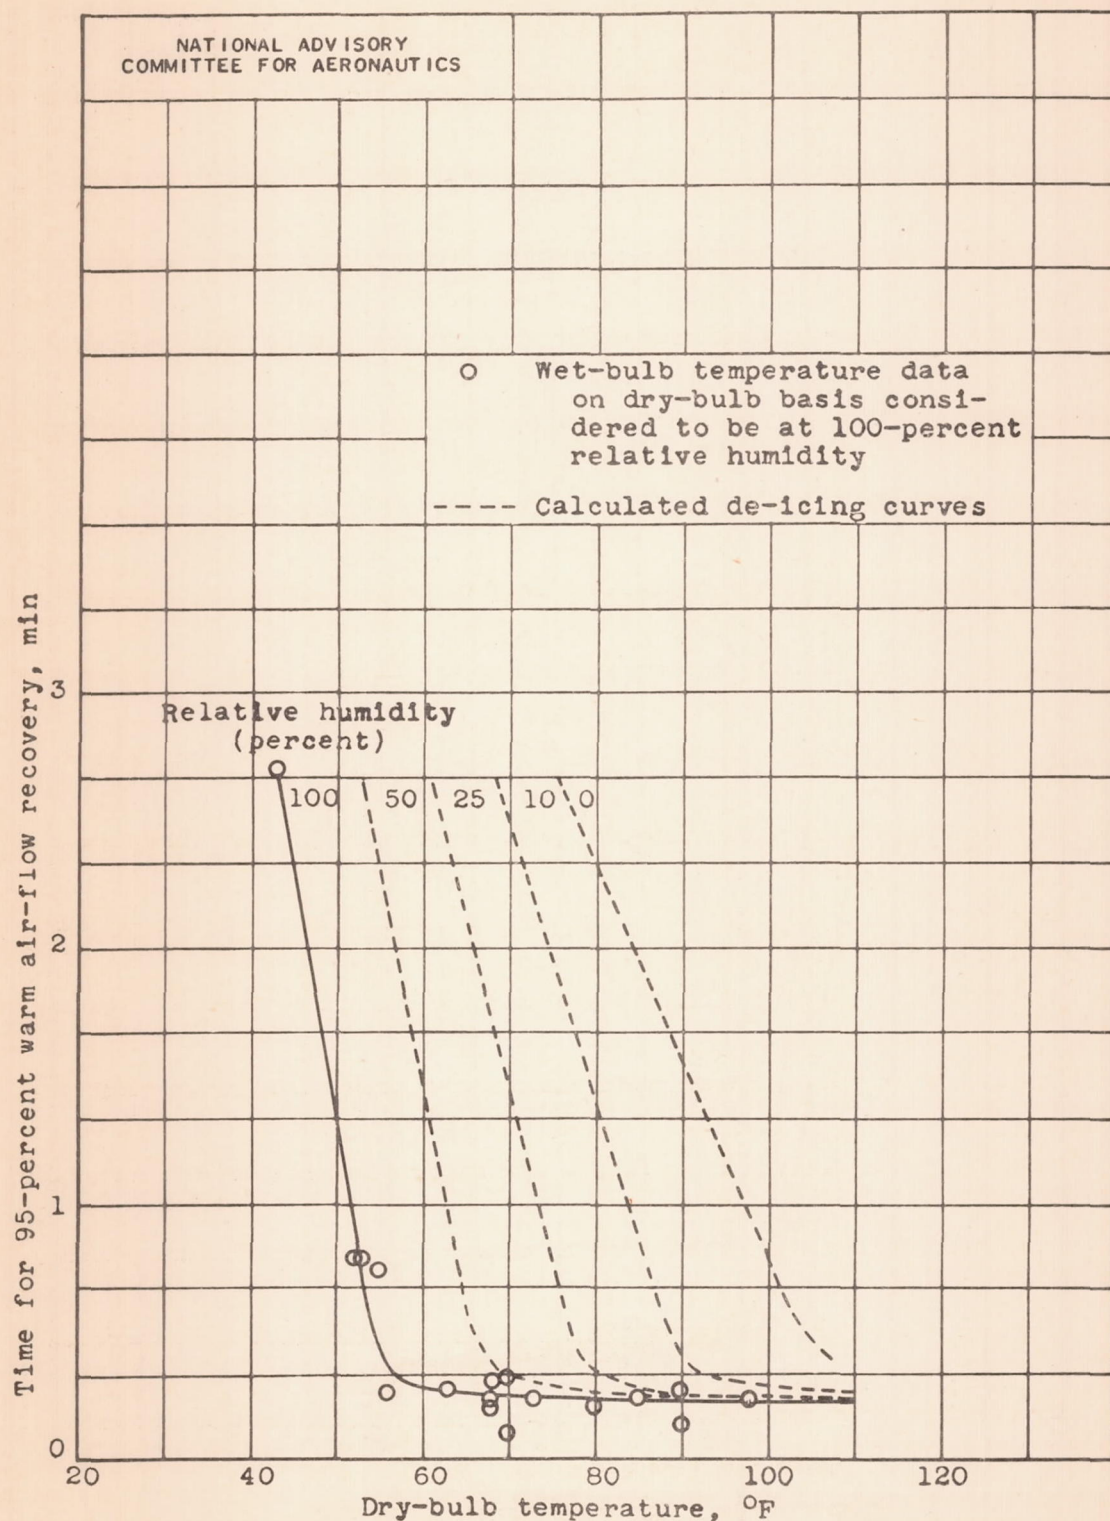
A previous investigation (reference 6) has demonstrated that de-icing time is a function of the wet-bulb temperature of the warm air. Calculated curves showing de-icing time after icing at 25° F for various relative humidities plotted against dry-bulb temperature are shown in figure 8.

Figure 8. - Effect of relative humidity and dry-bulb temperature on de-icing time after icing at 25° F.

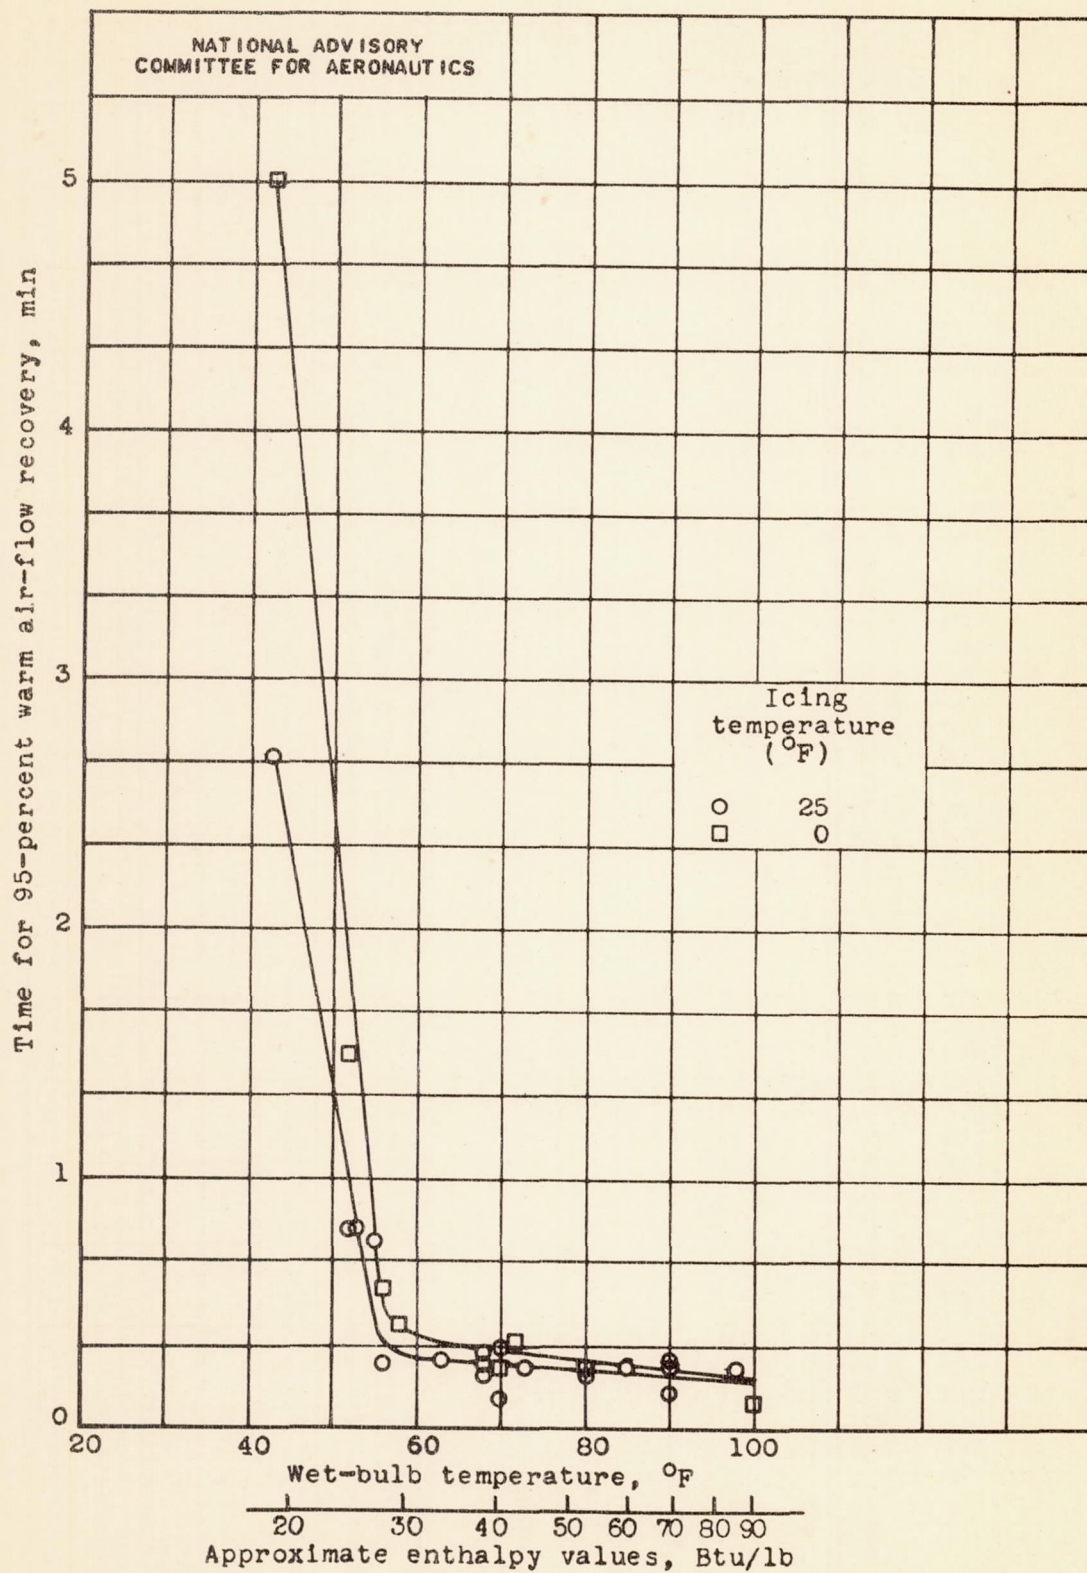
The de-icing time is greater for ice formed at 0° F than for that formed at 25° F (fig. 9). The heat content of ice at 0° F is only 12 Btu per pound less than for ice at 25° F and the difference between the heat requirements for melting a pound of ice in the two cases is only 8 percent. But the difference between the observed de-icing times varies from a maximum of 47 percent at a wet-bulb temperature of 43° F to an almost negligible difference at wet-bulb temperatures above 60° F. The discrepancy may be partly attributable to the variable effects of thermal capacity and conductivity of the metal parts of the carburetor with the effect of thermal capacity predominating at low rates of de-icing and the effect of conductivity bringing about more rapid ice-bond melting at higher rates of heating.

Figure 9. - Effect of icing temperature on de-icing time.

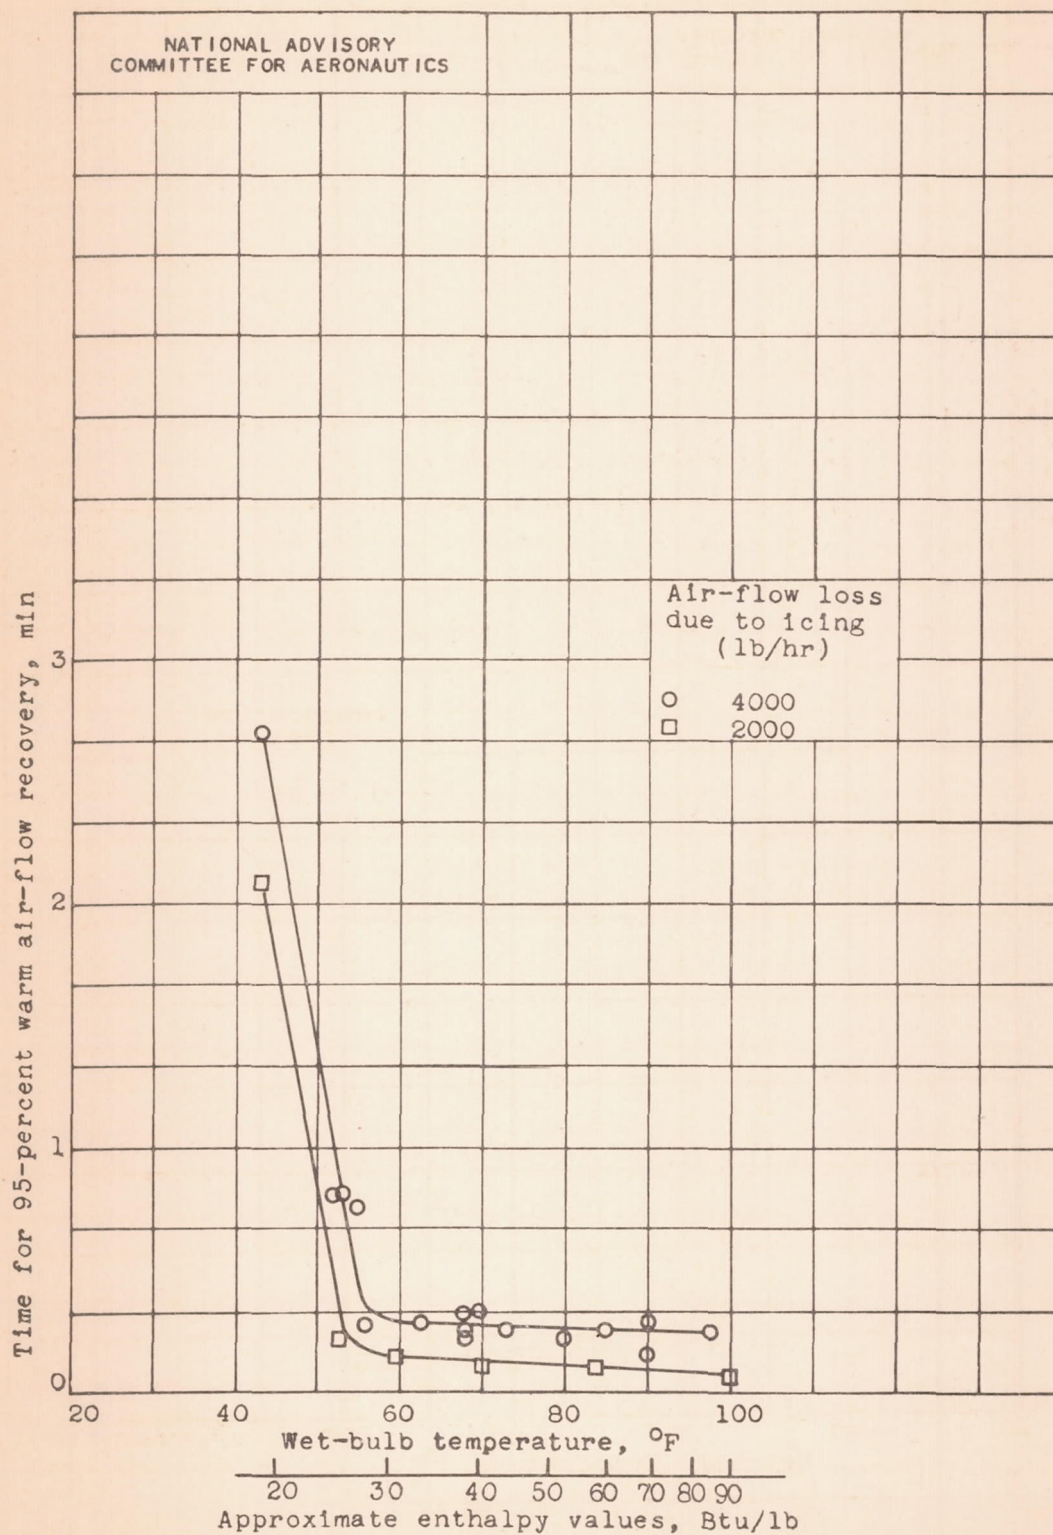
Effect of degree of icing on de-icing time. - The results of hot-air de-icing after ice is permitted to form under the same conditions at 25° F until an air-flow loss of either 2000 or 4000 pounds per hour is experienced are shown in figure 10. Icing under these conditions should give formations of the same type and in the same location, varying only in magnitude. This formation is confirmed by the fact that the de-icing curves for the two cases are similar but displaced with respect to de-icing time and no doubt are part of a complete family of such curves. This comparison shows that de-icing time is a function of the amount of ice to be removed.

Figure 10.- Effect of magnitude of ice formation on recovery time at 25° F.

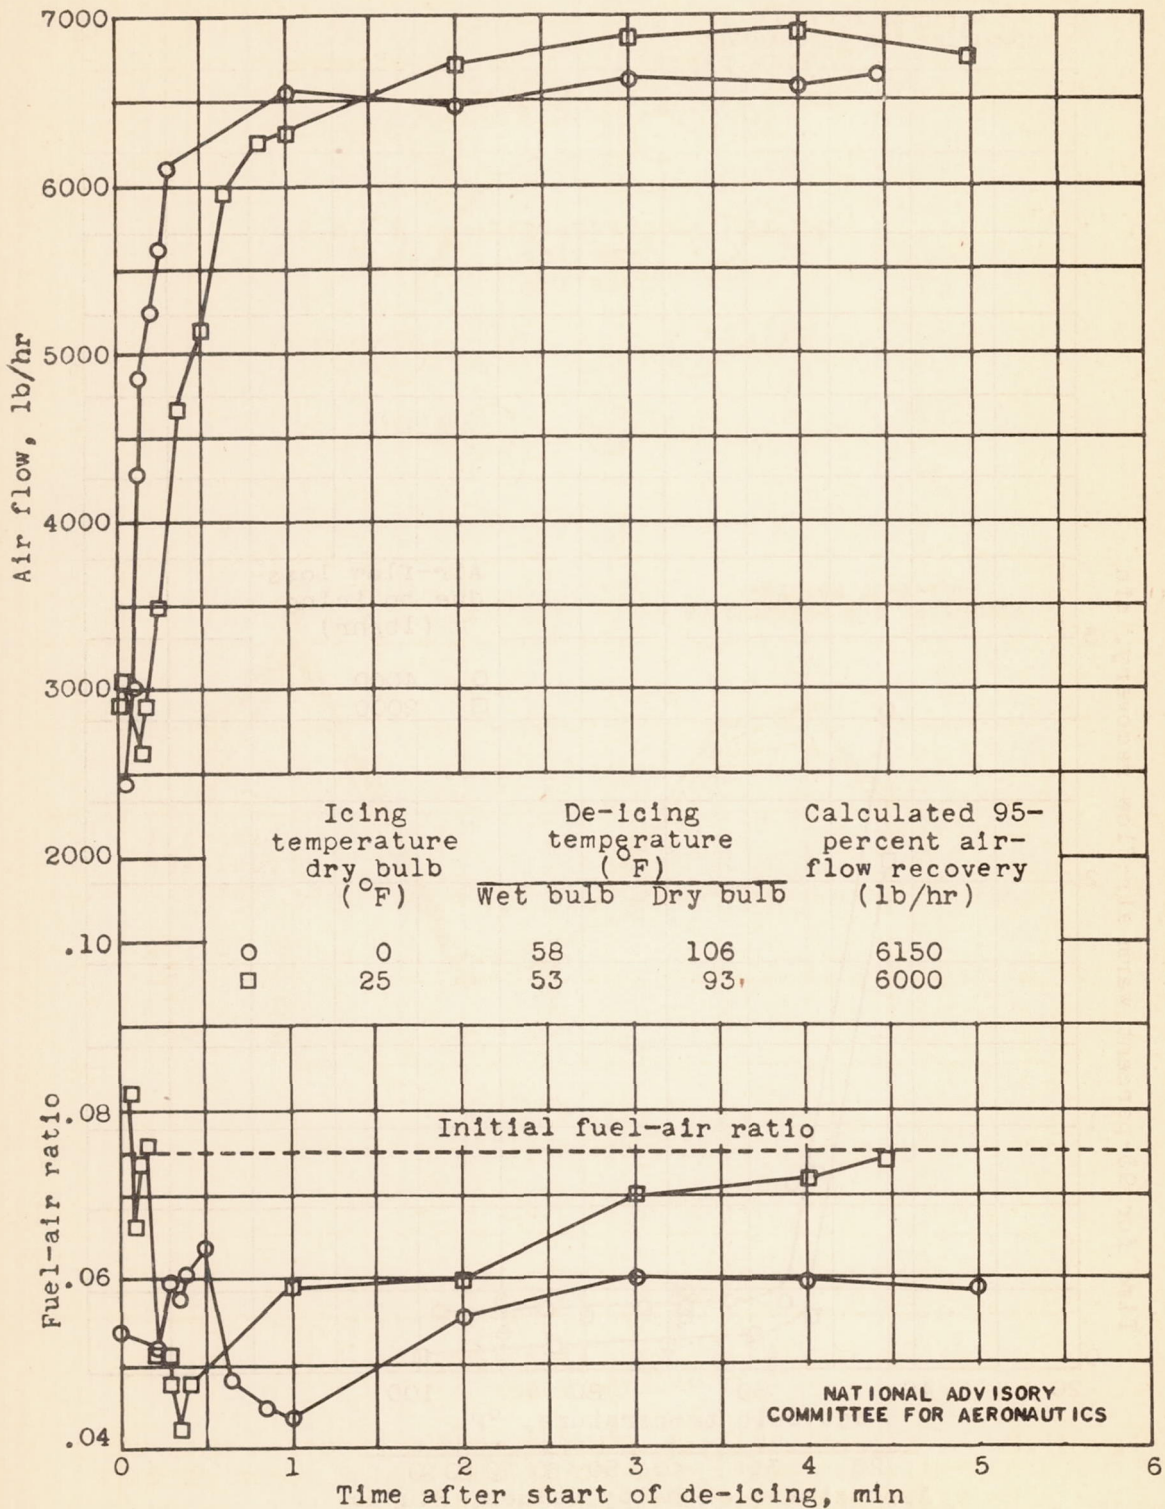
Fig. 11

Figure 11. - Typical time-history curves of hot-air de-icing.

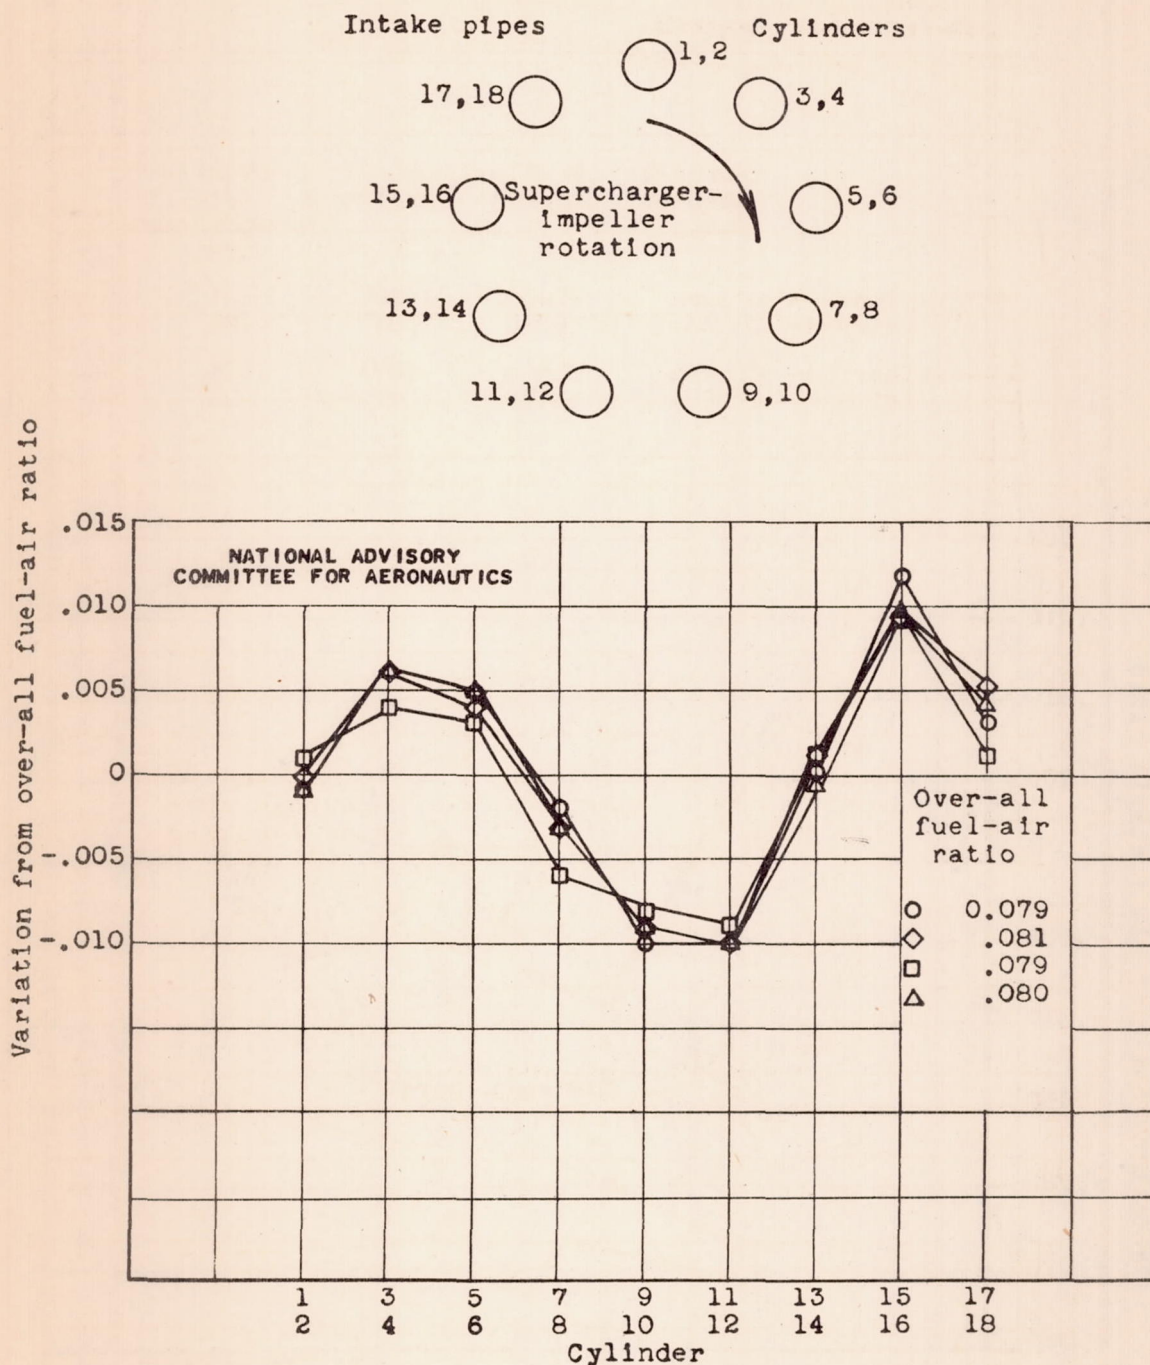
Mixture-distribution patterns at a carburetor-air temperature of 80° F and an engine speed of 2000 rpm with wide-open throttle show good reproducibility (fig. 12), the maximum deviation from the mean for each cylinder being approximately 4 percent. The results of this investigation are in fair agreement with reference 7 with respect to the spread in fuel-air ratios between the richest and the leanest cylinders. The geometry of the patterns obtained at approximately the same conditions of engine speed, throttle angle, over-all fuel-air ratio, and carburetor-air temperature do not agree with the patterns of reference 7. The data obtained from the laboratory installation under conditions of steady flow are of value in determining the effect of ice accretions on mixture distribution but are probably not indicative of the distribution for a complete engine.

Figure 12. - Reproducibility of mixture-distribution data at carburetor-air temperature of 80° F and engine speed of 2000 rpm with wide-open throttle.

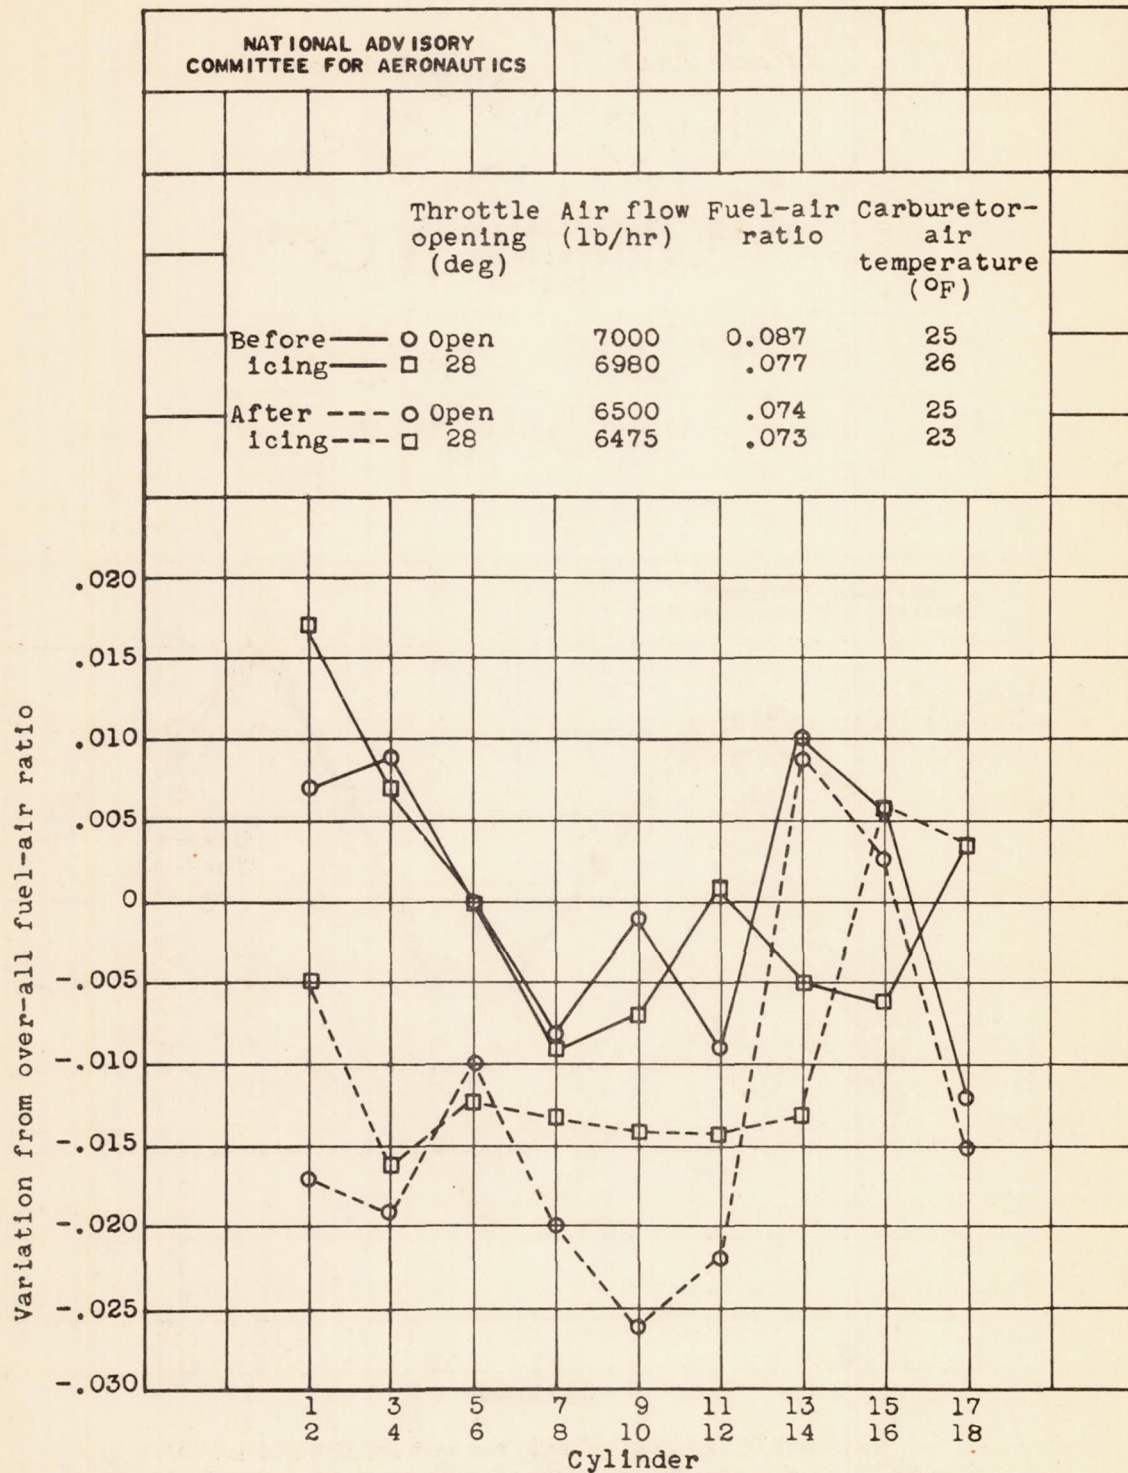
Effect of icing on mixture distribution. - The change in mixture distribution obtained at full-open and part-throttle (28°) settings when the induction system is allowed to ice under impact-icing conditions is shown in figure 13. In both cases, the respective initial and final air flows and carburetor-air temperatures are approximately the same. The average spread in fuel-air ratios between the richest and the leanest cylinders at full throttle is greater after icing of the carburetor than before but is less after icing at a throttle angle of 28°. The most significant effect of icing the carburetor is the decrease in over-all fuel-air ratio in both cases.

Because of the absence of erratic metering in dry-air conditions at low altitude, the effect of water or ice in the air-metering passages of the carburetor is considered to be the cause of the serious lowering of fuel-air ratio experienced under icing conditions (fig. 13), as well as the cause of failure to restore fuel-air ratio upon completion of air-flow recovery during hot-air de-icing.

Figure 13. - Effect of carburetor icing on mixture distribution at two different throttle angles.

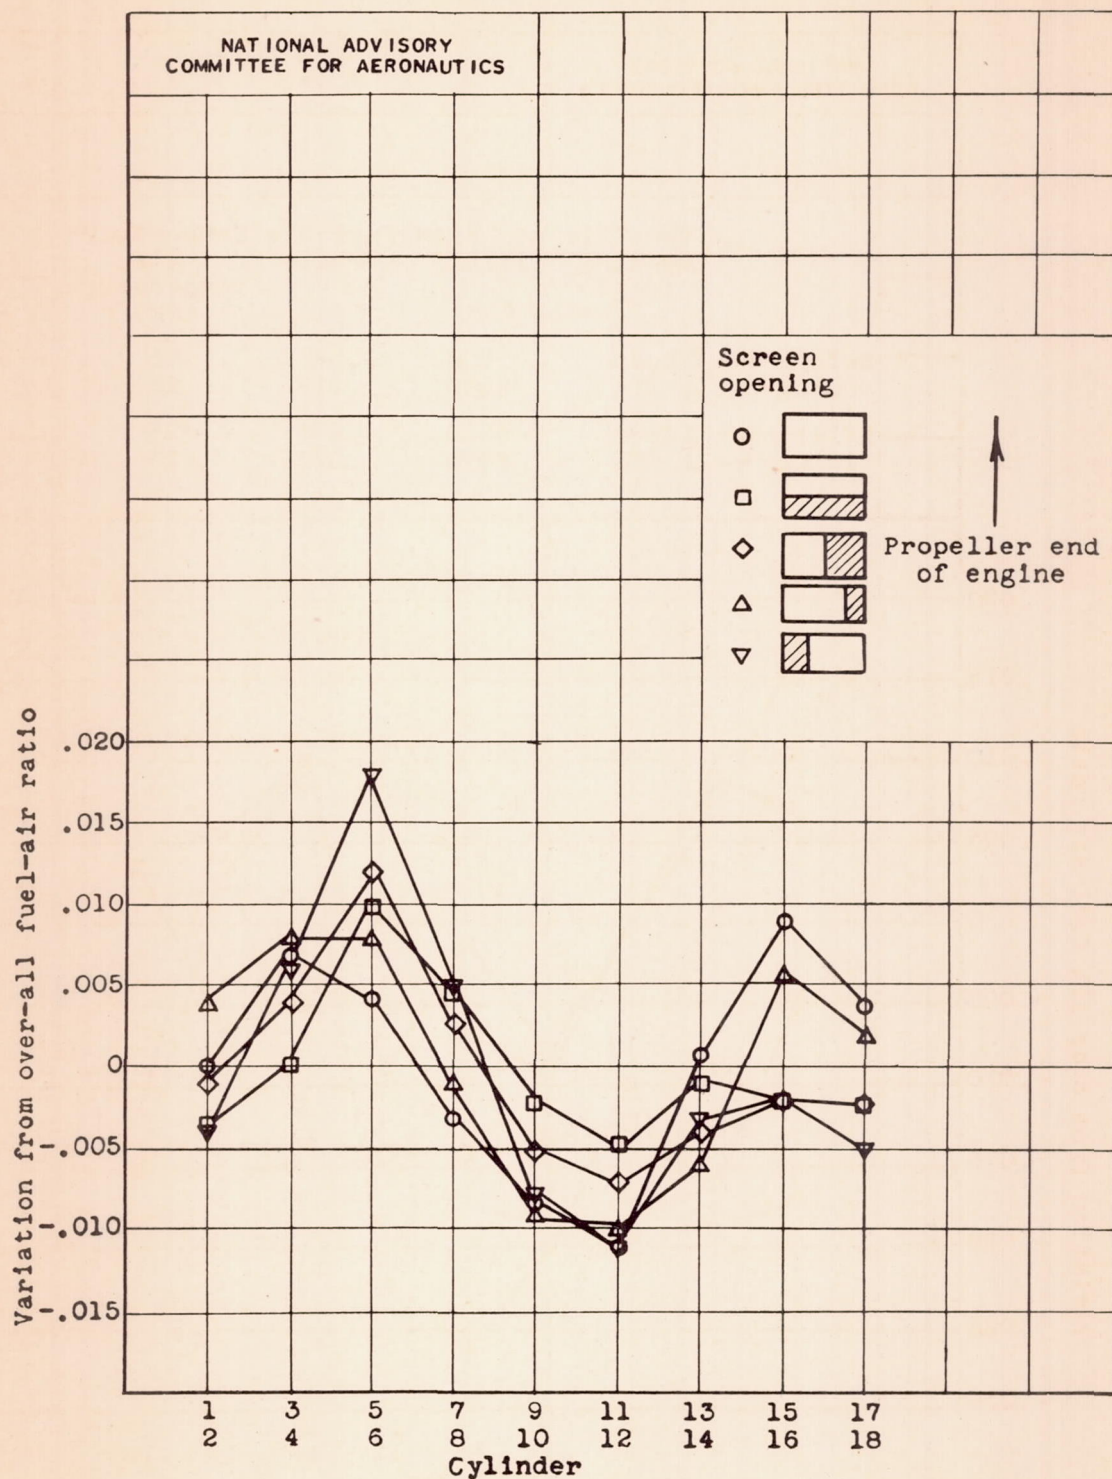
Effect of location of simulated-ice formation on mixture distribution. - The effect on mixture distribution of blocking the carburetor screen with pieces of cardboard to simulate the blocking caused by ice formations dislodged from upstream duct walls during hot air de-icing is shown in figure 14 for a carburetor-air temperature of 77° F. A typical distribution pattern obtained with full screen opening is included to provide a basis for comparison. In general, the distribution patterns are similar. The difference between the richest and the leanest cylinders is approximately the same for the blocked and unblocked screen except that blocking the left quarter of the screen apparently affects the distribution the most, causing a fuel-air ratio

Figure 14. - Effect of simulated-ice-formation location on mixture distribution at a carburetor-air temperature of 77° F.
